Monitoring Data Record

Project Title: Twin Oaks (R-2302) COE Action ID: 199920857
 Stream Name: Perennial stream flowing into the New River DWQ Number: 990491
 City, County and other Location Information: Sta. 39+50 – 48+50 on US 21 S of Twin Oaks
 Date Construction Completed: N/A Monitoring Year: (1) of 1
 Ecoregion: _____ 8 digit HUC unit 05050001
 USGS Quad Name and Coordinates: _____

4th Quarter – August 2005

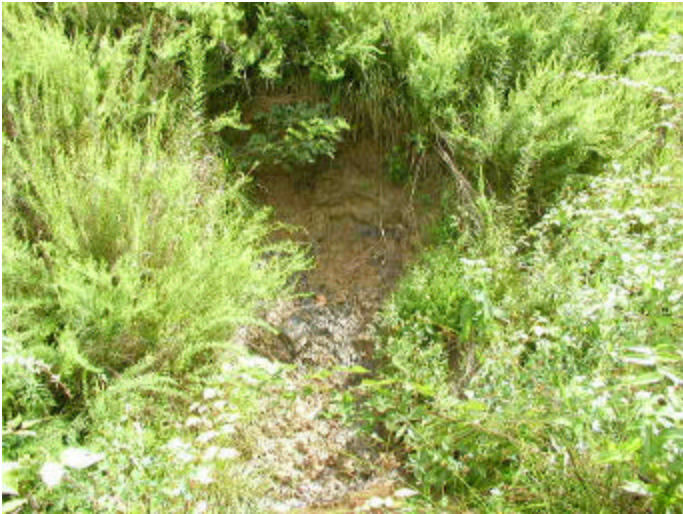
Other Information relative to site photo reference: Photo 9 documents undercutting of stream bank.

For the most part the stream is very stable at this time. There is some undercutting of the streambank noted in photo 9 due to high water flows or hillside runoff on the lower portion of the stream. As stated in the 2nd quarter report there is some severe hillside erosion above the silt fence away from the stream near STA 40. However, erosion has not altered the stream at this time. Repairs to the roadway embankment have not taken place. Erosion control measures are still continuing to be maintained to prevent sediment loss.

Photo 9 (undercutting of streambank)
